ACRS 2019 Daejeon, Korea

EOPEN PUC1 - A New Approach to Flood Risk Management

M. Ferri, D. Norbiato, F. Zaffanella

Autorità di Bacino Distrettuale delle Alpi Orientali

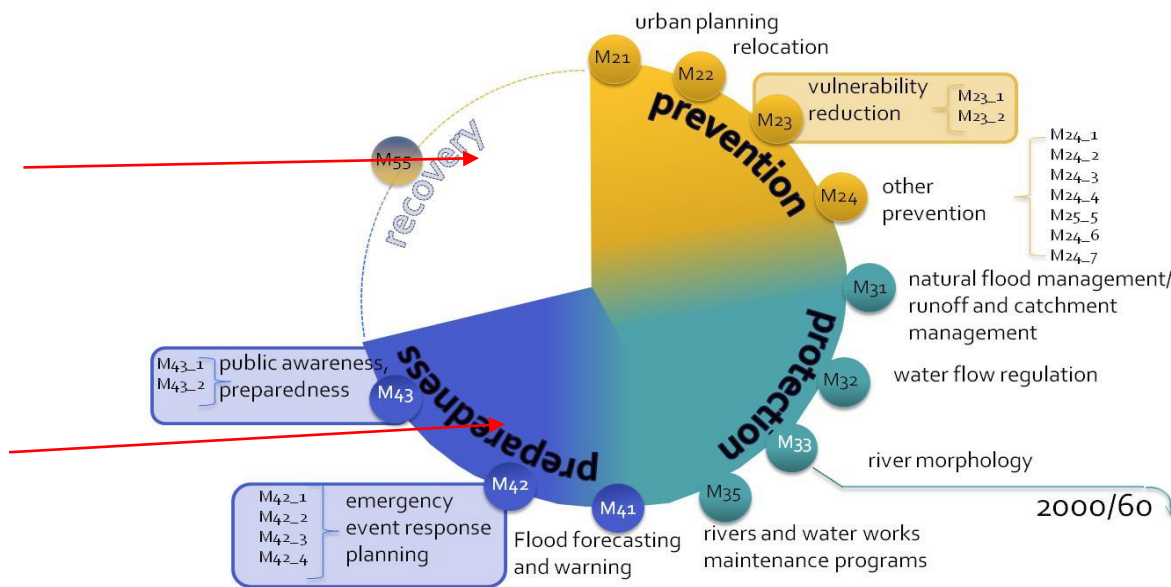
The Flood Risk Management Plan includes different measures to manage the risk of floods including both structural and non structural measures

Scheme of the Flood Risk Management Plan measures

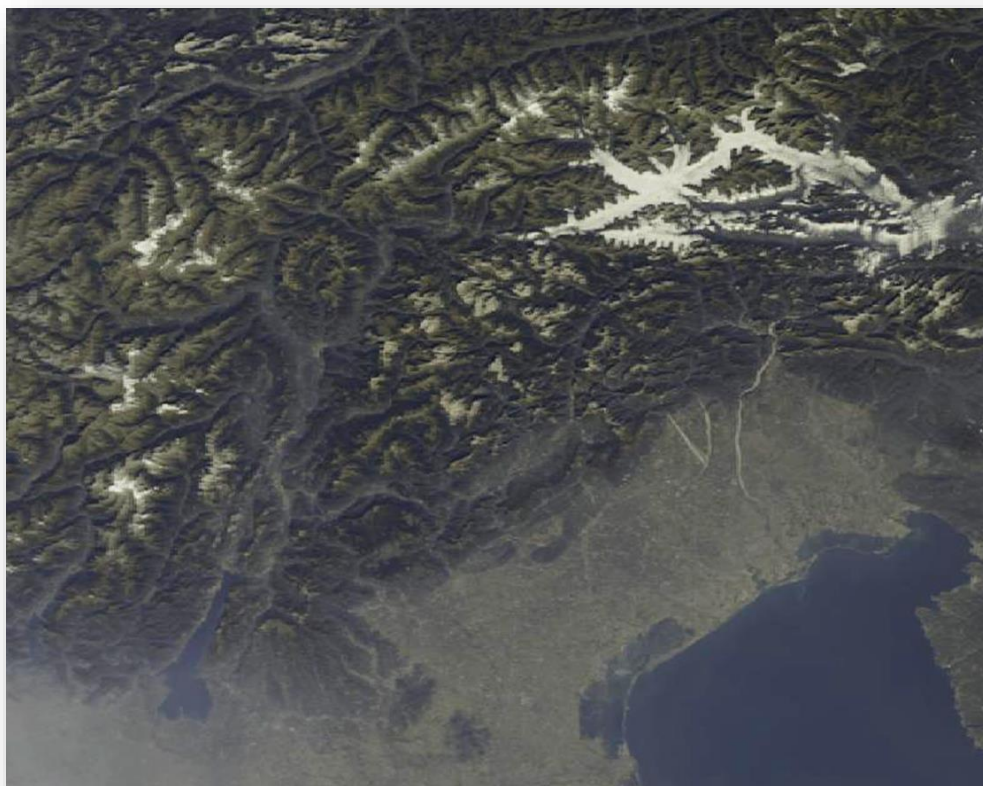
Snow cover

Copernicus Sentinel 3
OLCI L1 13-10-2018

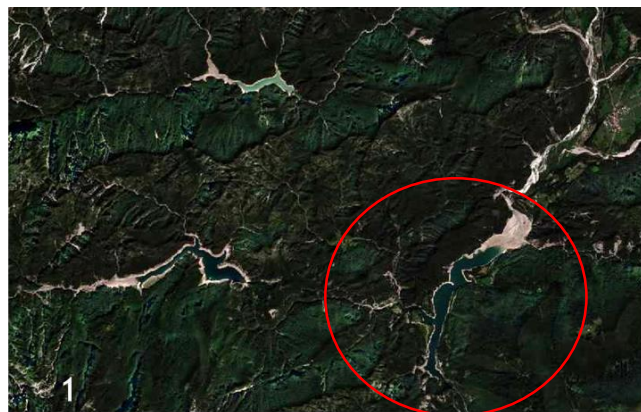
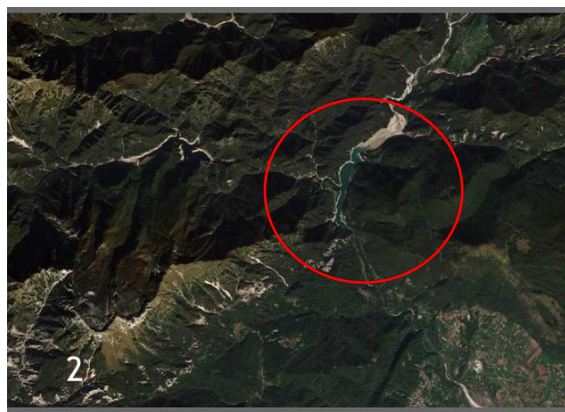
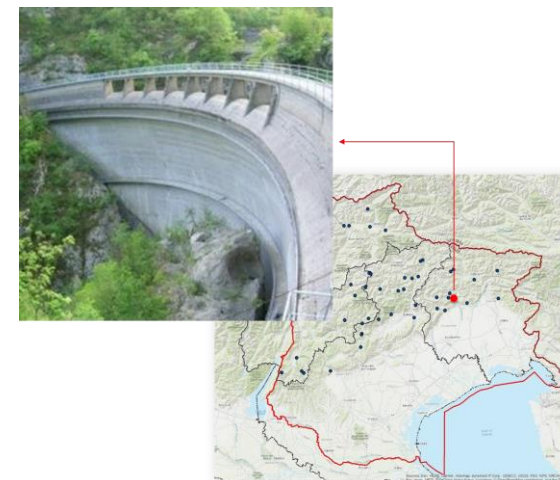
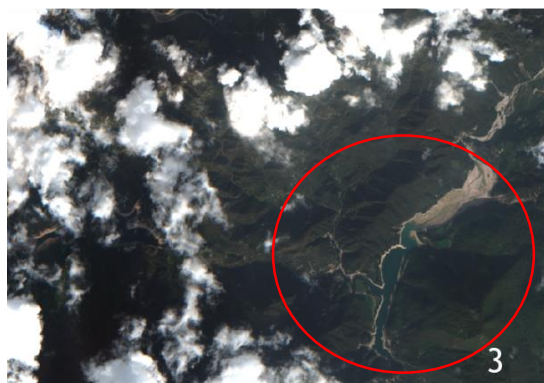
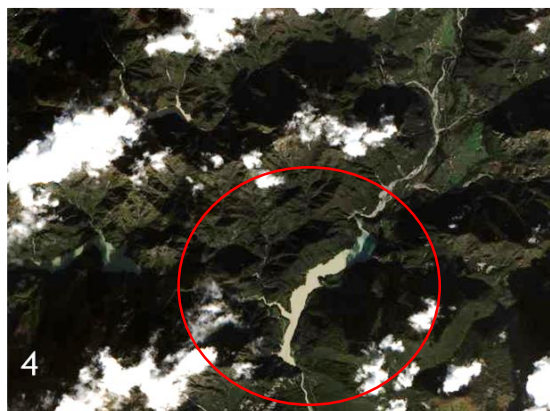
Dam status, Ponte Racli

- 1- Sentinel 2 27-8-18 RGB
- 2- Sentinel 2 11-10-18 RGB
- 3- Sentinel 2 21-10-18 RGB
- 4- Sentinel 2 31-10-18 RGB

RGB= bands 4,3,2

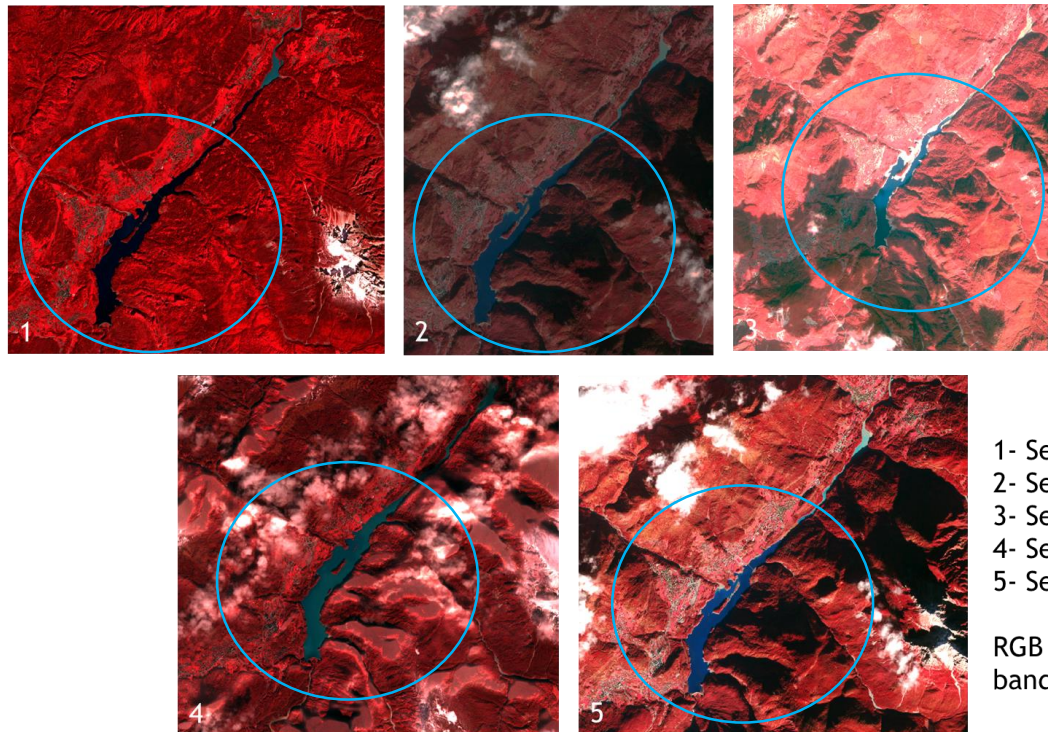
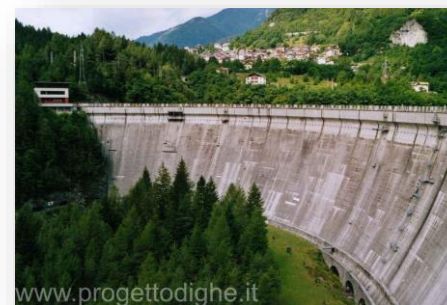
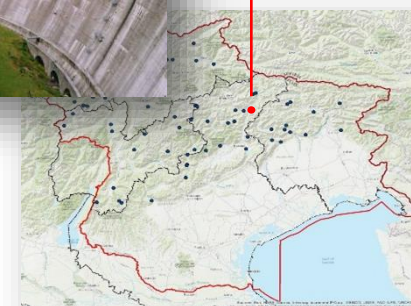
Dam status, Pieve Cadore

- 1- Sentinel 2 27-8-18 RGB IR
- 2- Sentinel 2 11-10-18 RGB IR
- 3- Sentinel 2 21-10-18 RGB IR
- 4- Sentinel 2 31-10-18 RGB IR
- 5- Sentinel 2 10-11-18 RGB IR

RGB IR: False colour RGB IR band

False colour RGB IR= bands: 8,3,2

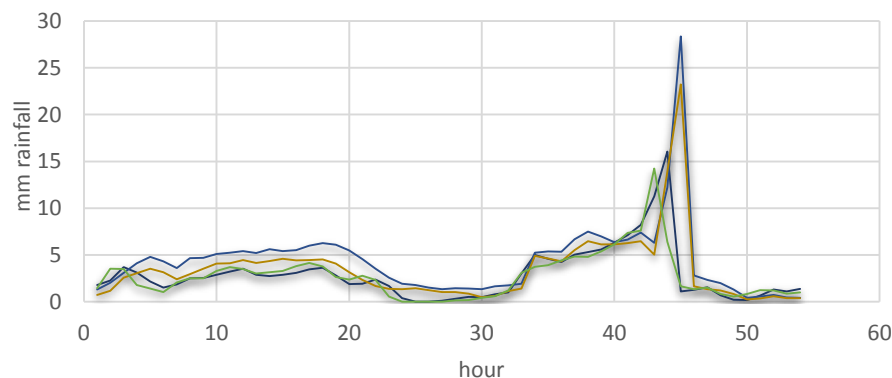
Hirlam_28_h00_ mean hourly precipitation for each basins

— Piave a Nervesa della Battaglia
— Cellina a Montereale
— Tesina a Longare
— Meduna a Meduno
— Brenta a Bassano

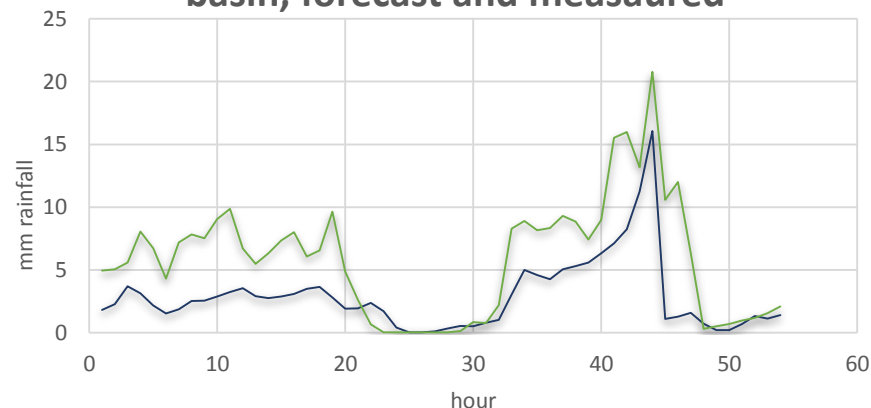
Hourly precipitations for Piave river basin, forecast and measured

— Piave a Nervesa della Battaglia HIRLAM 28 h00
— Piogge Piave misurate Nervesa

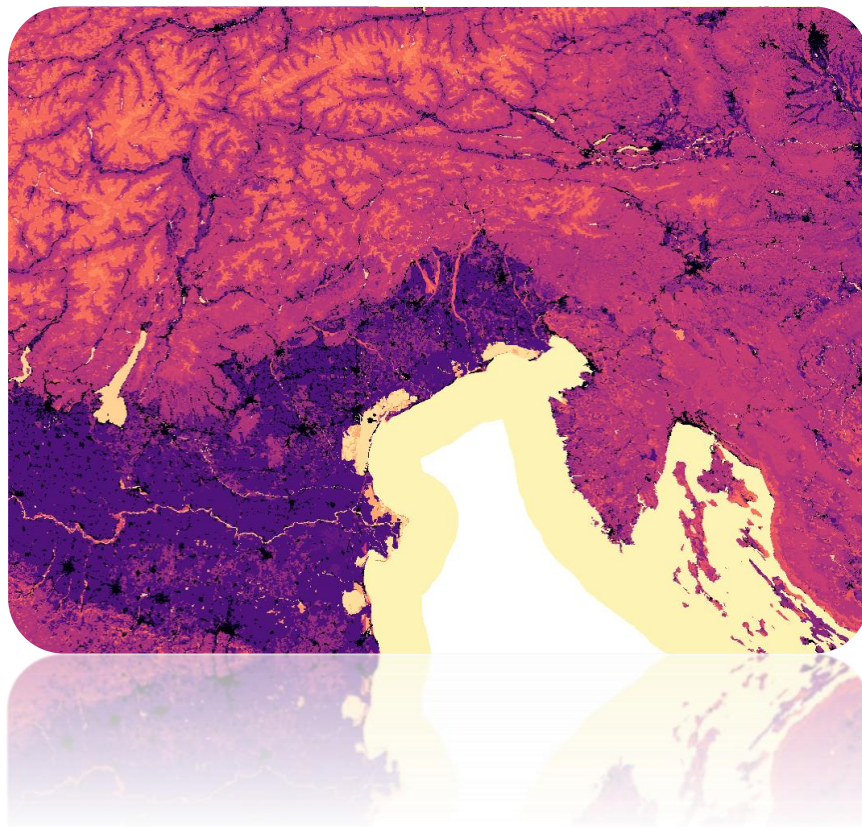
Other variables; Land use, Corine Ic 2018

Copernicus
Land Service,
Corine LC 2018, 100m
resolution

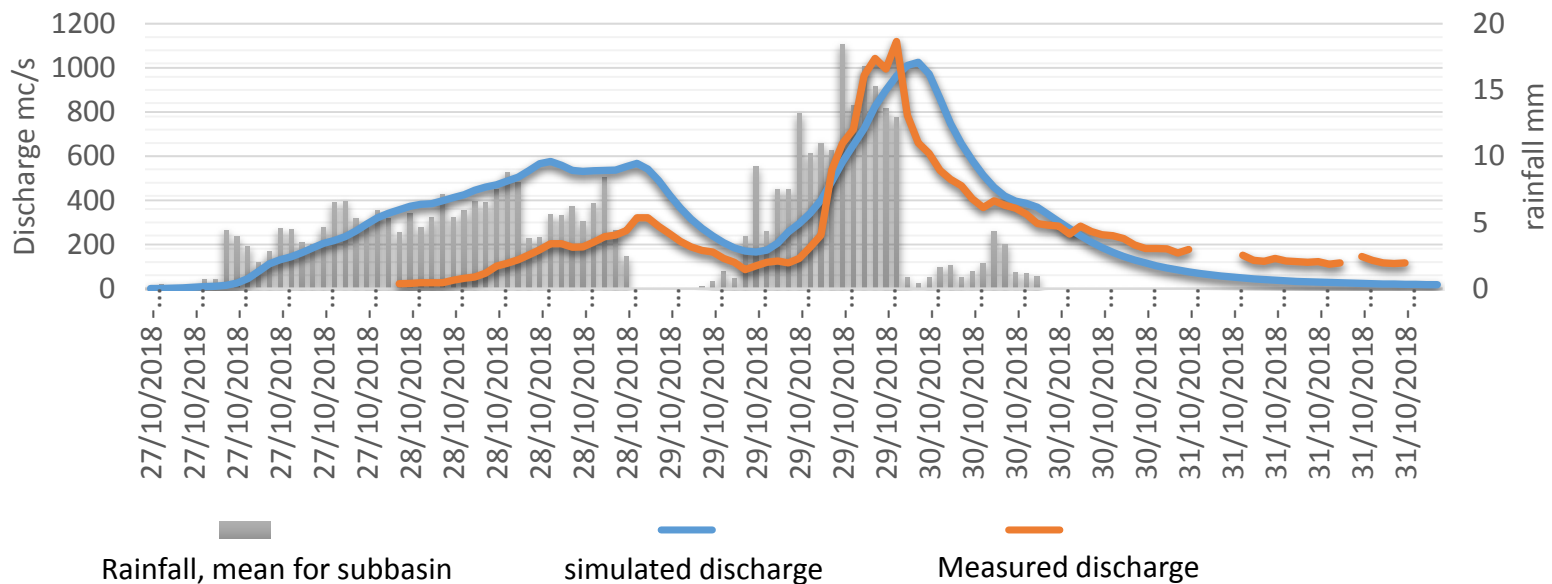
AMICO Results: closure section of most affected basins

Piave river discharge at Pieve Cadore river section

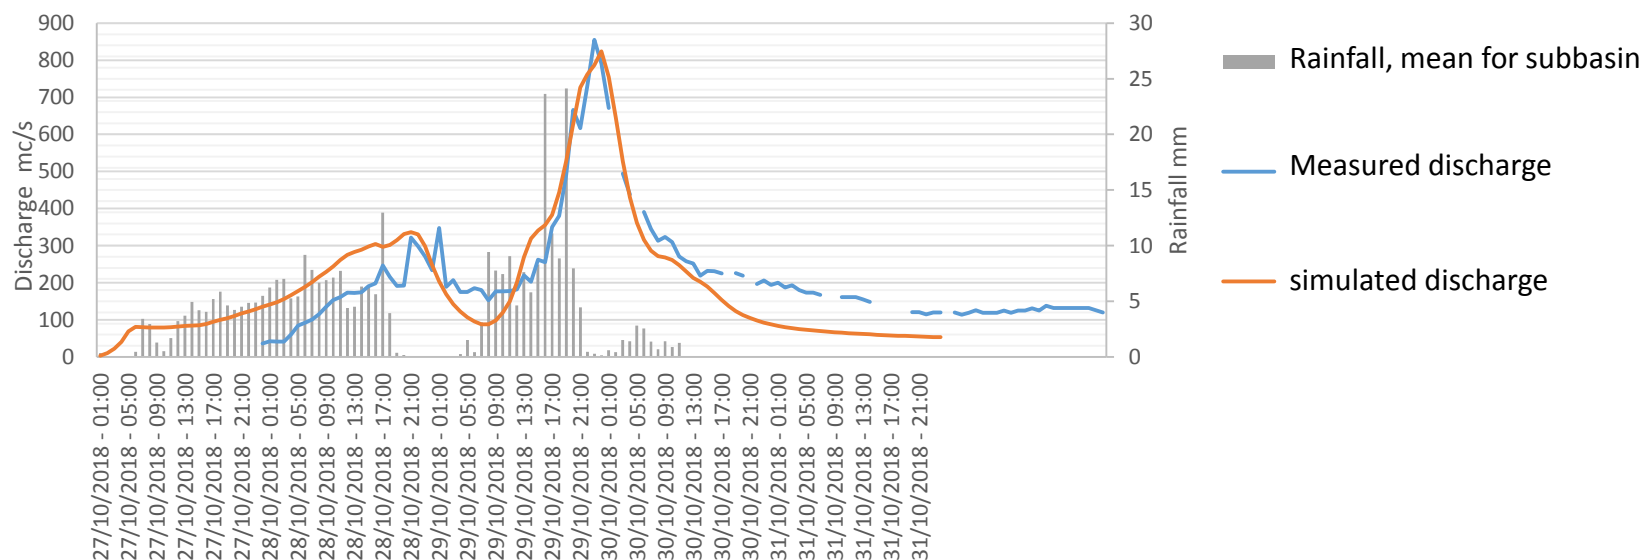
AMICO Results: closure section of most affected basins

Cismon river discharge at Corlo Dam river section

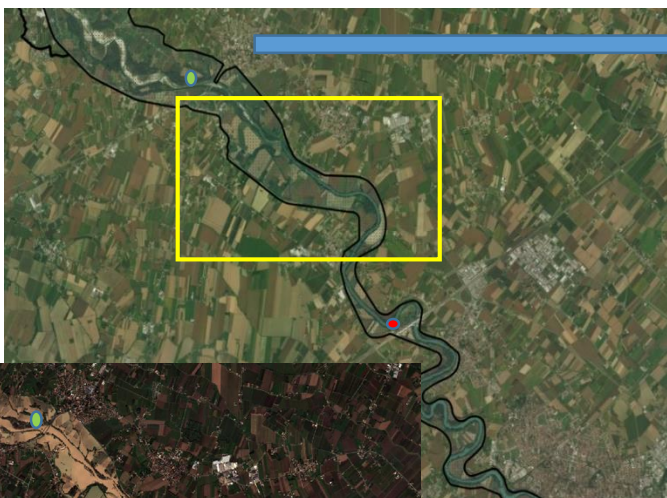
Piave river fluvial area (area where the river develops morphological processes)

Piave 29-10-2018 - Sentinel 1 radar elaboration by "Autorità di Bacino Distrettuale delle Alpi Orientali" (AAWA)

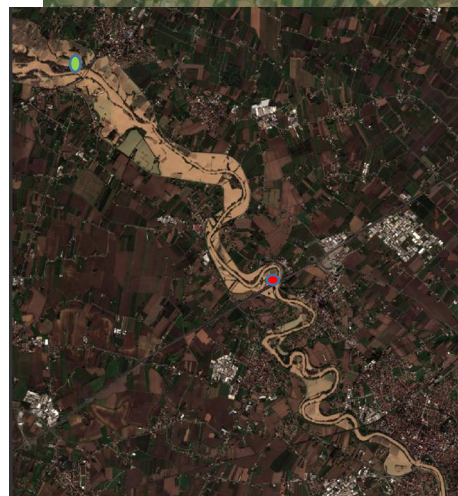
Sentinel 2, end of October 2018

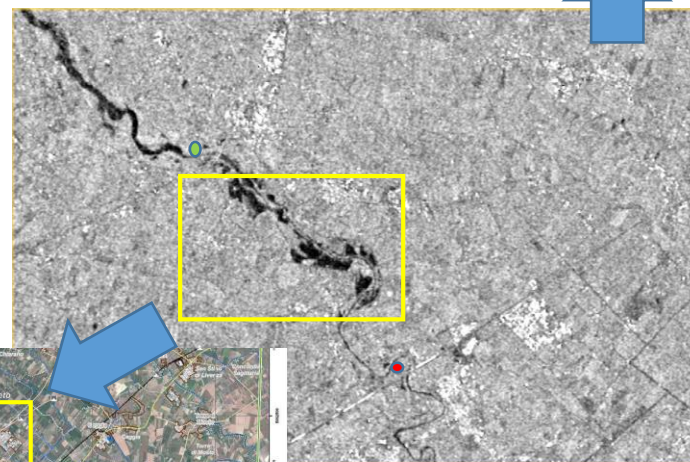
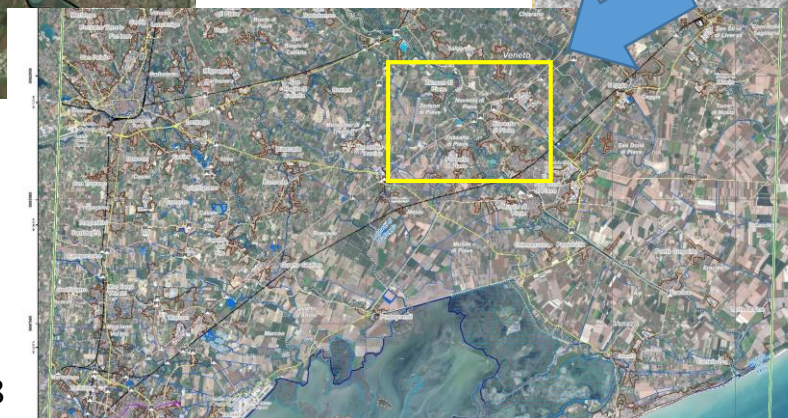
False positives from Copernicus Emergency Management Service (EMS)

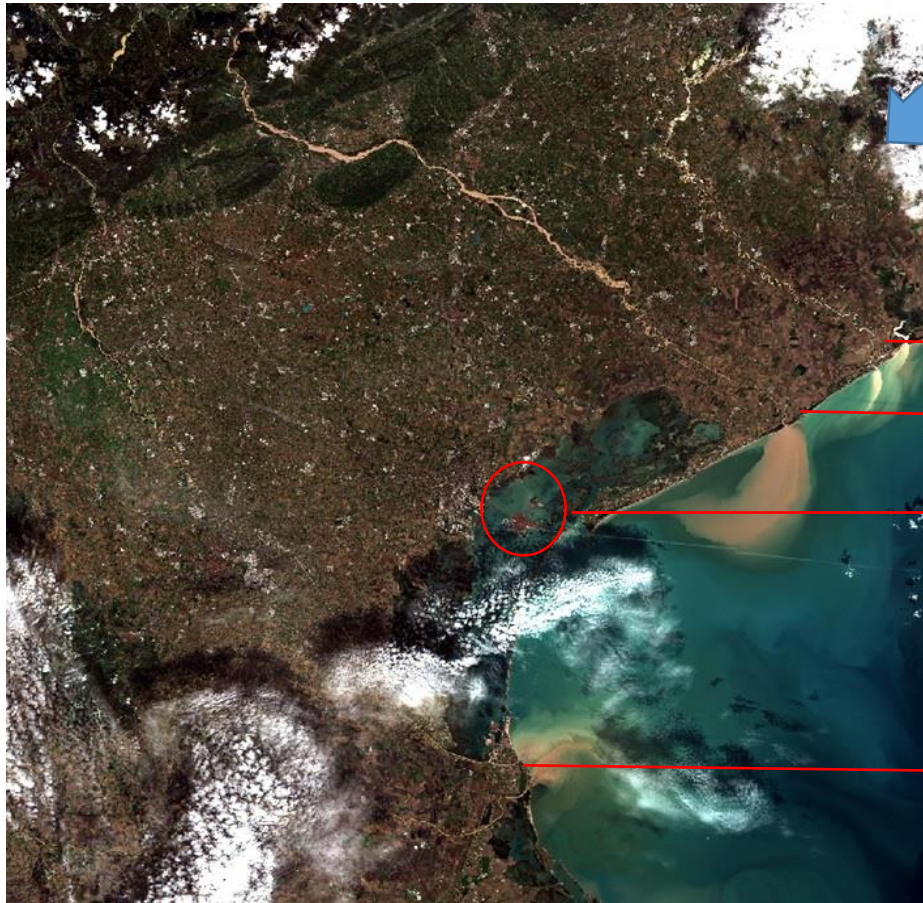
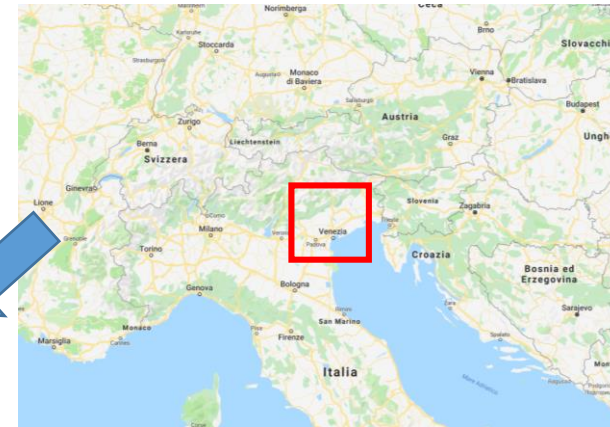
River sediments discharge after VAIA storm
